Manhole Inspection Summary

Manhole # S21II_006MH

Insp Date: **6/25/07 8:58 AM**

Location Address: **1811 BRUCE ST** Cross Street: **WESTWOOD AVE**

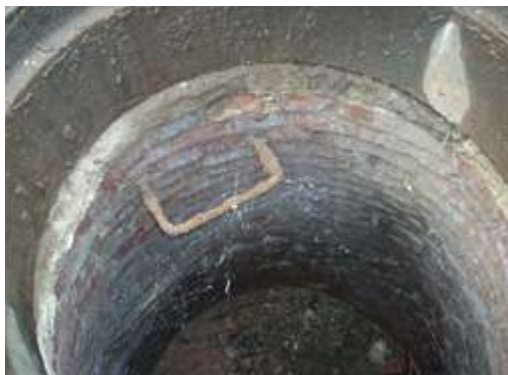
Defect 2

Steps Count: **1** Missing: **3** ☒ **Corroded**

MISSING AND CORRODED STEPS

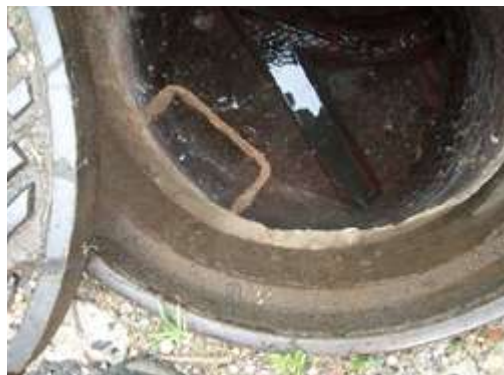
Defect 1

Frame Offset: **1** (in.) Condition: ☒ Sound ☐ Cracked ☐ Leaks

FRAME OFFSET

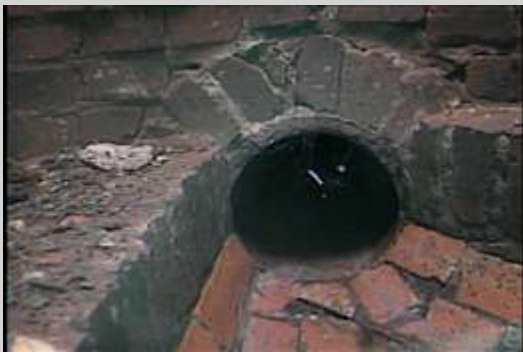
12 O'Clock Outflow

Pipe Height: **8.4** (in.) Rod and Bar (Angled)
Pipe Material: **Clay** ☐ Pipe Lined
Invert Depth: **7.92** (ft.) Flow Characteristics: **Slow**
Deposits: ☒ None ☐ Mud ☐ Sludge ☐ Debris ☐ Grease
Silt Depth: (in.) Deposits Extent:
Infiltration: **None** Pipe Seal Cond: **Cracked**
